NRL/MR/6130--01-8540

## Command Naval Surface Atlantic Fleet (COMNAVSURFLANT) Soot Issue Ship Visit — USS *Hawes* (FFG-53) and USS *Guston Hall* (LSD-44)/USS *Tortuga* (LSD-46)

March 26, 2001

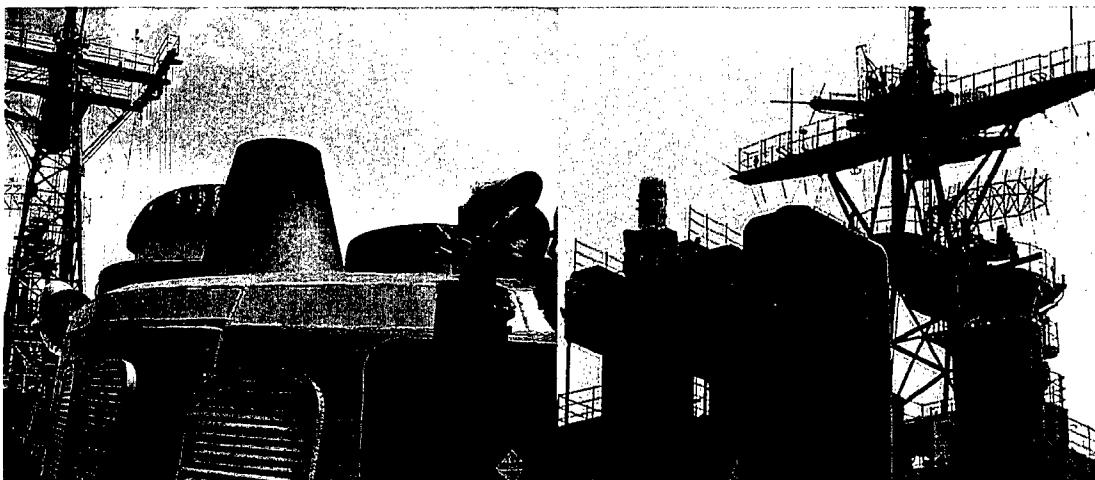
Figure 1: A) The soot, even though prevalent on the stack, also adheres to the antennas, lighting fixtures, deck, etc. in the vicinity surrounding the diesel stacks on the USS HAWES. B) Running soot resulting from the diesel stacks on the USS GUNSTON HALL is quite apparent, even from a distance.

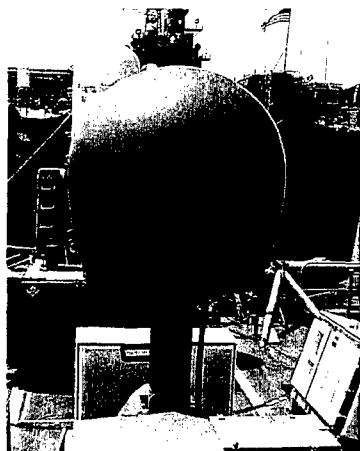
Figure 5: The cleaning procedures for the composite material protecting the tracking radar system are addressed within a Navy specification requiring SIMPLE GREEN cleaner.

In conversations with the ships force of the USS HAWES, removal of the soot from the various surfaces is usually performed at sea. Most areas are cleaned, especially the non-skid, using a high-pressure fire hose to wash the soot overboard—the tracking antenna (Figure 5)

is cleaned using Simple Green as defined within NSTM specification. Per ships force, the pressure wash approach is effective in removing the soot. The drawbacks per the USS HAWES are the lack of deck drainage and deck flatness with the FFG design—this may not be relevant on another class of ship. Another drawback is that it has to be done at sea due to the concern regarding overboard discharge (environmental).
